LANDSLIDING AND MUDEFLOWS AT WRIGHTWOOD, SAN BERNARDINO COUNTY, CALIFORNIA

SPECIAL REPORT 136

PART I: WRIGHT MOUNTAIN LANDSLIDE: RENEWED MOVEMENT IN 1967

PART II: WRIGHT MOUNTAIN MUDFLOWS: SPRING 1969

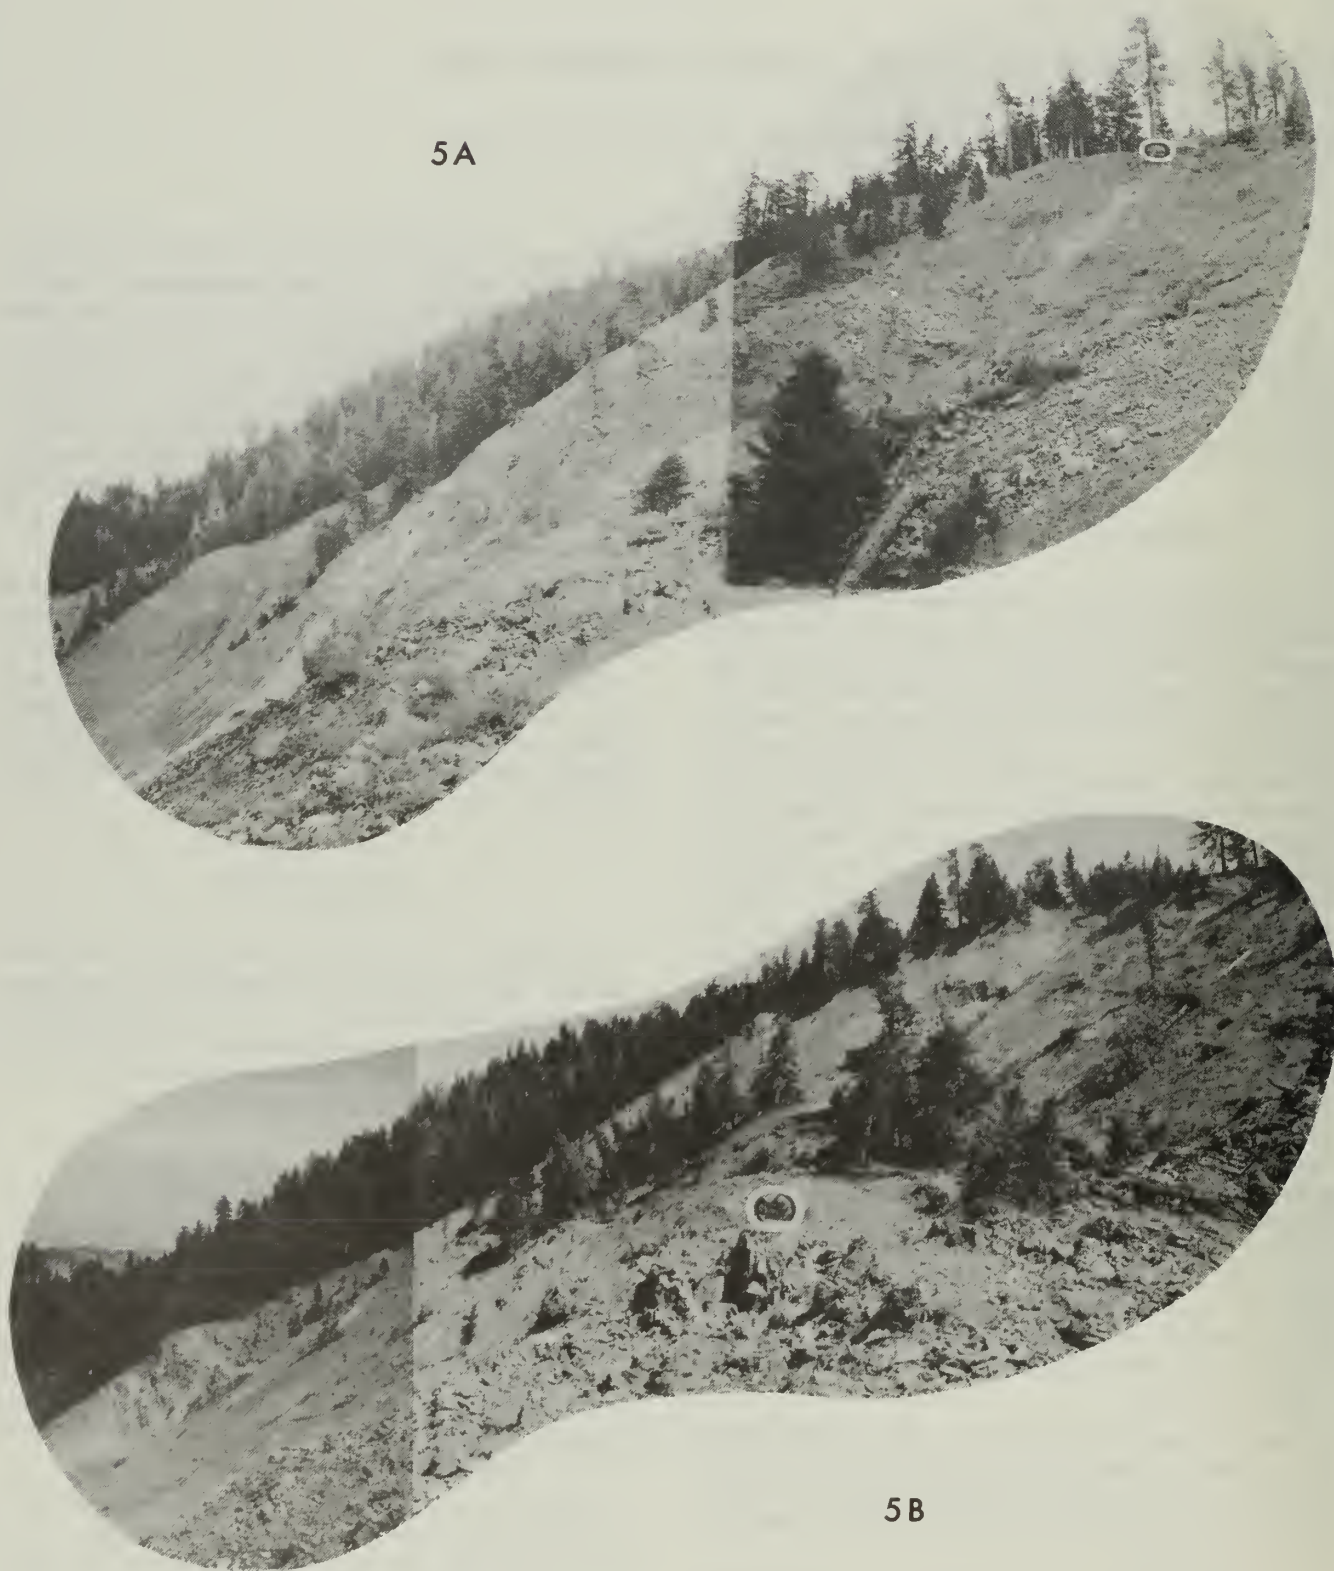
Figure 5. View looking east across the profile of the active block. Figure 5A was taken on September 27, 1967, when the toe of the active block first became apparent. Figure 5B was taken in August 1968, after failure of the active block. Circled pine tree trunk shows the magnitude of the vertical displacement.

Branching headwater tributaries of Heath Creek drain the head and steep upper slopes of the active parts of the landslide (figure 5). The trunk drainage of Heath Creek is incised to bedrock in the lower part of the steep slopes of the landslide toe area, forming a *bedrock chute* with a gradient of 31 degrees between elevations of 7,000 and 7,500 feet. At the foot of the bedrock chute, the gradient abruptly decreases to 17 degrees, and downstream the bottom of the canyon is filled with alluvium. This *alluviated canyon* reach extends 3/4 mile downstream to the apex of Heath Canyon fan at an elevation of 6,500 feet. From the relatively steep upper end the gradient decreases gradually to 7 degrees at the lower end. The “narrows” discussed earlier is located about midway through this reach and was used as a landmark by Sharp and Nobles (1953). Streamflow at the apex of the fan is funneled by a flood control levee into a man-made channel along the east side of the fan. This *controlled channel* extends 1/2 mile downstream to a point where the gradient decreases to 5 degrees. There, near the confluence of the fans from Heath and Sheep Canyons, the flood control levee swings away from the hillside, leaving a broad area with a low gradient where mudflow deposition is encouraged. The principal area of deposition for the climactic stage of the 1969 mudflows was in this controlled depositional reach.

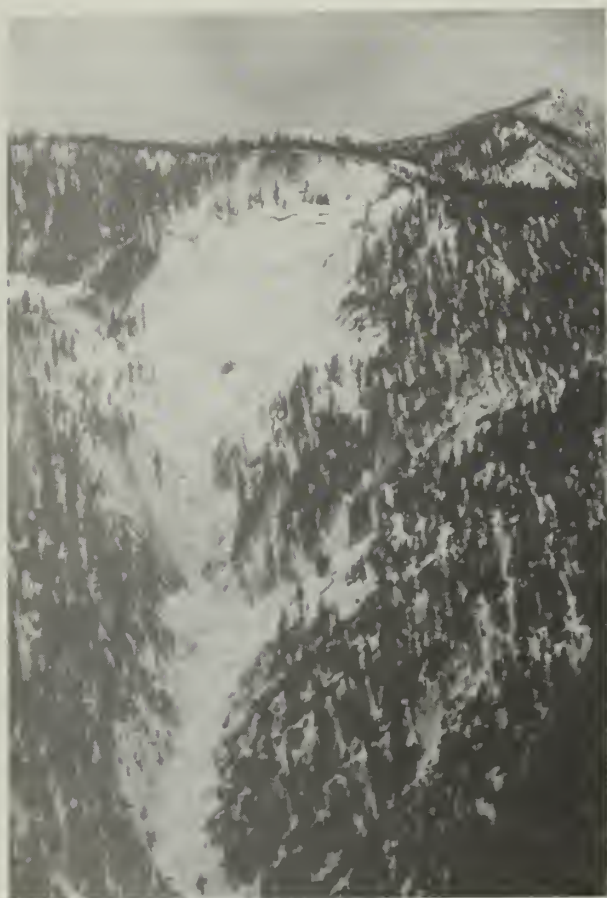
Figure 7. Wright Mountain Landslide, March 1969.

A deep snowpack developed during the winter of 1968–69. Snow depth on Wright Mountain, measured on March 3, 1969 (figure 7), ranged between 68 and 104 inches with an equivalent water content of 26 to 45 inches (J.R. Townsend, personal communication, 1969). Thus, early in the spring of 1969 upper Heath Canyon contained abundant debris and an adequate source of water for spring mudflows.

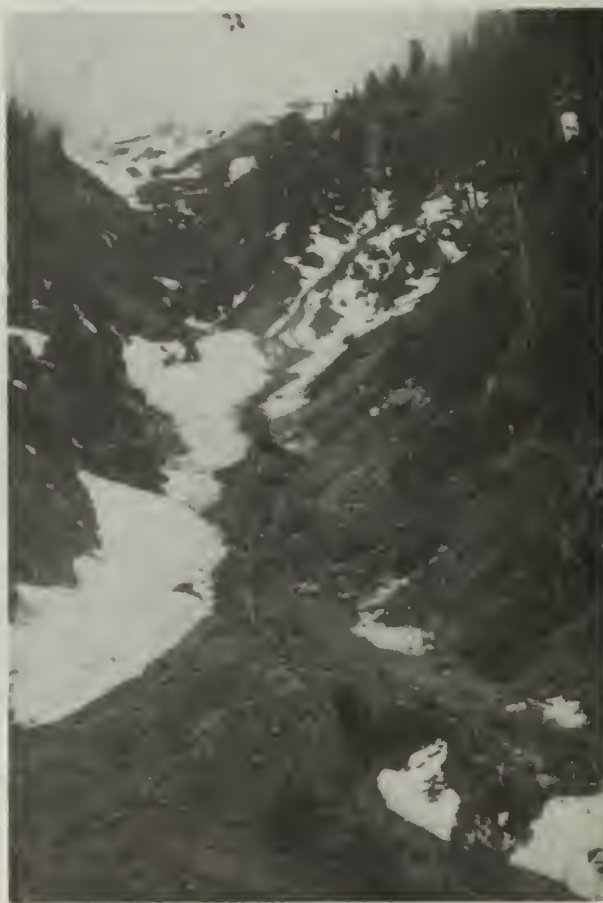
Figure 8. View up alluviated canyon bottom (17th reach) during the waxing stage. Debris for mudflows at this time (May 5, 1969) is in the area immediately below the clouds.

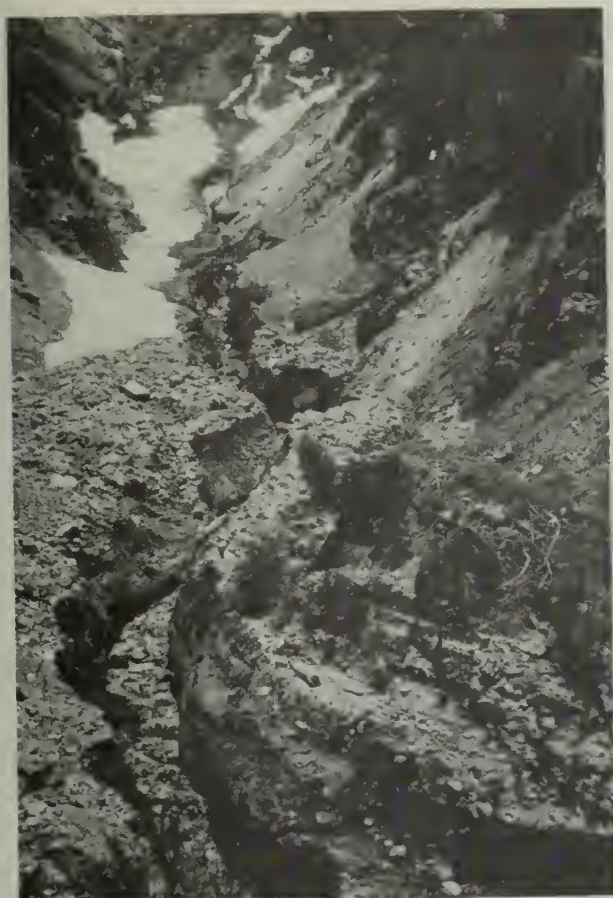
Figure 9. Same view as figure 8 taken on May 18, 1969 after a single mudflow channel has been cut (approximately 12 feet depth) during climactic stage.

channel was extended downstream through the alluviated canyon (figure 9) from the bedrock gap to the apex of the fan, where the mudflows entered the man-made flood control channel. Subsequent mudflows travelled through the entire length of the alluviated canyon reach in this U-shaped channel, as well as across the apex and upper part of the fan in the man-made flood control channel, without observable net deposition or erosion. Deposition took place chiefly on the middle and lower parts of Heath Canyon fan and was limited by flood control levees on the east side of the fan. A few of the larger flows deposited debris as far downstream as the confluence of Heath and Swarthout Creeks at the toe of the fan, 2 miles from their point of origin.

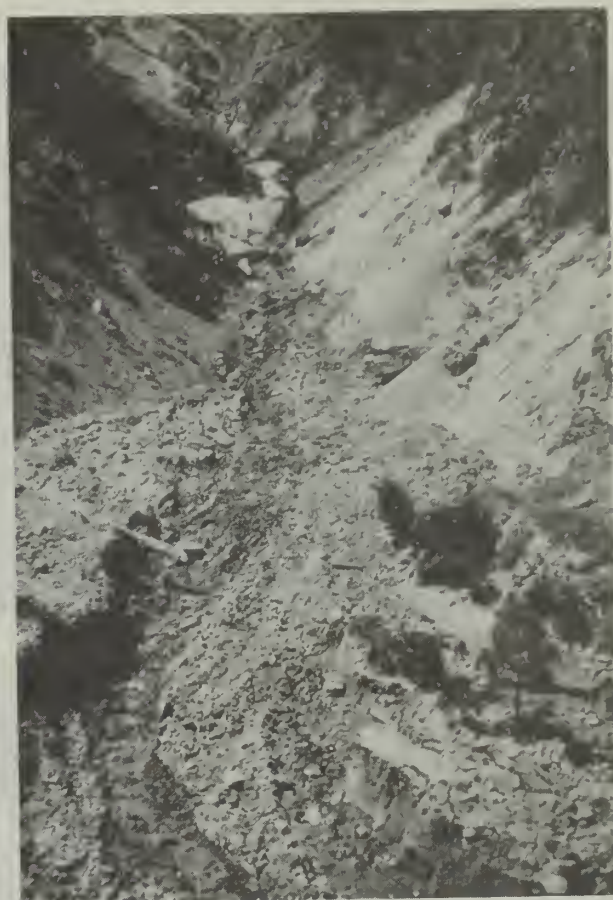
Figure 10. Same view as figure 8, taken during the waning stage of the mudflow cycle after most of the deep channel had been filled.

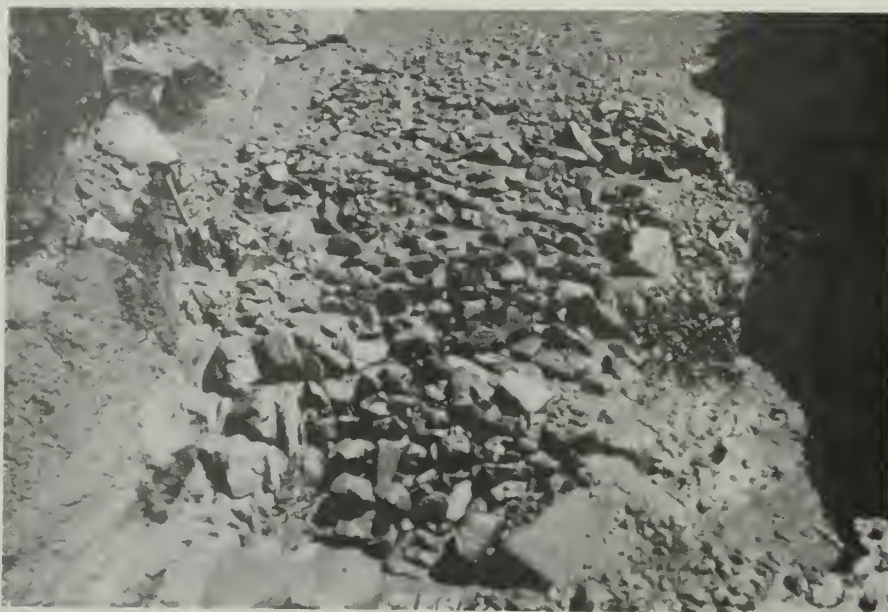
Figure 11. Near vertical angle view of rock front of mudflow immediately above bedrock gap. Note the well-sorted nature of the rocks (larger ones two feet in diameter) constituting the front, and also the apparent decrease in clast size and the progressive increase in mud content behind the front.

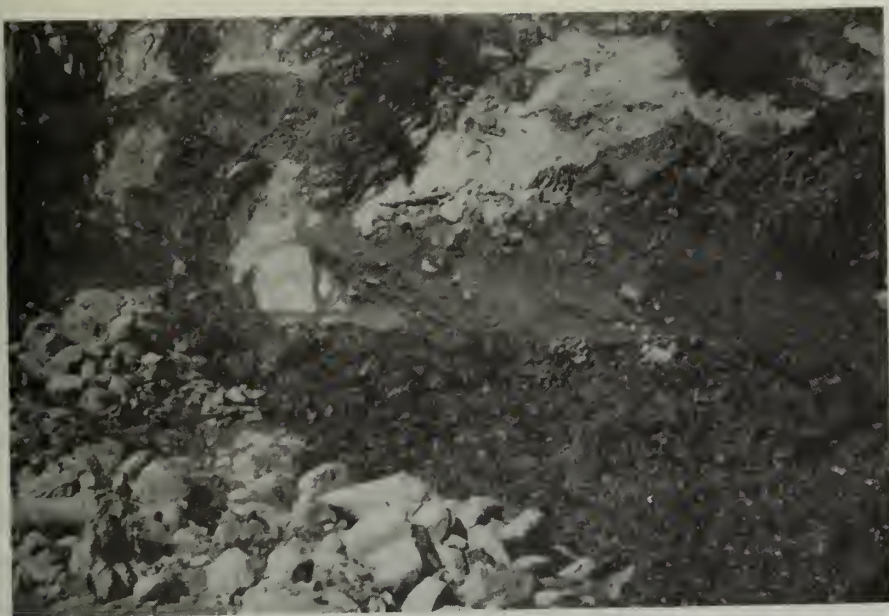
Figure 13. View of turbulent-flowing muddy water following a mudflow, above the bedrock gap during the mature stage. Note the line of the upper level of mud passing through two upper bushes deposited during the waxing stage and subsequently removed during the climactic stage.

mud and rock and frequent chunks of snow, followed by a slurry of mud which passed progressively into muddy water (figure 13). The trailing muddy water tended to flush finer-grained loose debris from the channel, leaving it clear with a rocky bottom. Between the passage of mudflow surges, there was a minor but nearly continuous flow of muddy water. At individual points of observation along the channel, a temporary diminution or cessation in the flow of water frequently, but not invariably, preceded the approach of another mudflow. Debris damming the upper channel caused temporary interruption of the flow of muddy water.

fashion. Individual clasts tended to remain in the same relative position in a flow, slowly rotating and occasionally disappearing or, if on the snout, occasionally toppling down the front. As the viscosity of the flow decreased behind the rocky material, where it consisted of a slurry, or debris-laden water, the flow became turbulent (figure 13).

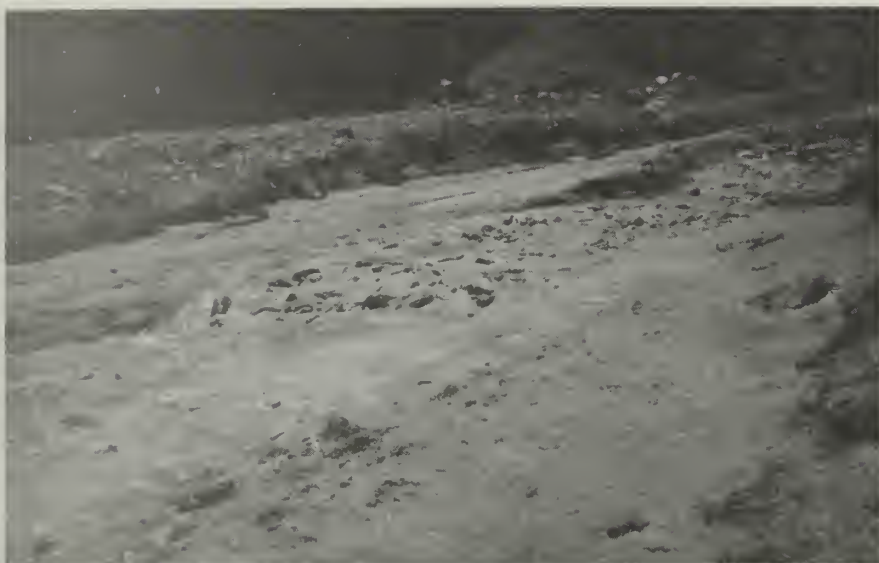
Figure 15. View of the mudflow immediately above area of principal deposition. Note the low front and its mixture of rocks and mud. The width of flow is approximately 12 feet.

During the climactic stage, mudflows reached the gentler gradient of Heath Canyon fan and moved across its upper part where individual masses tended to merge, forming larger, more continuous flows in which the rocky snouts of former individual mudflows were recognizable only by short flow segments containing concentrations of boulders. The segments between boulder accumulations appeared visibly bimodal, with boulders interspersed in sandy mud (figure 15, 16, 17).

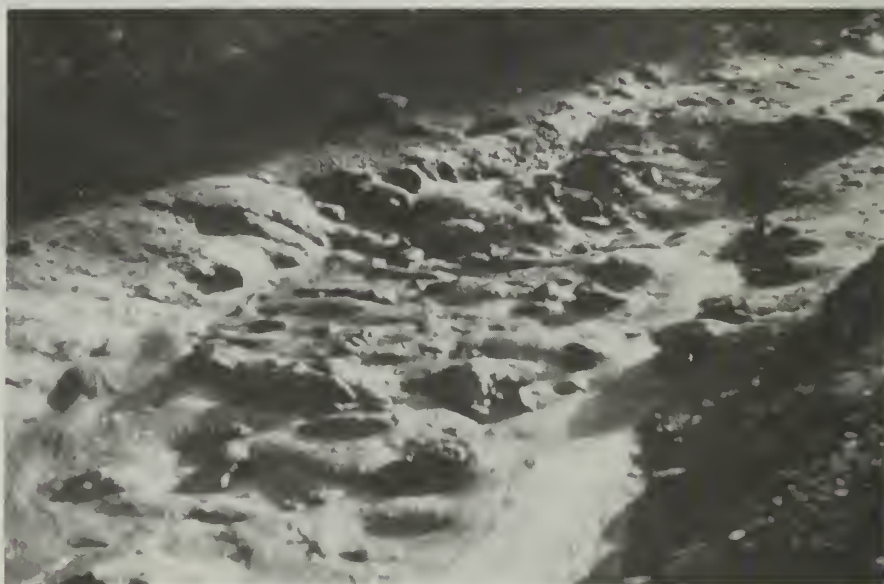
Figure 16. View of the mudflow above the area of deposition. Here the width of flow is about eight feet.

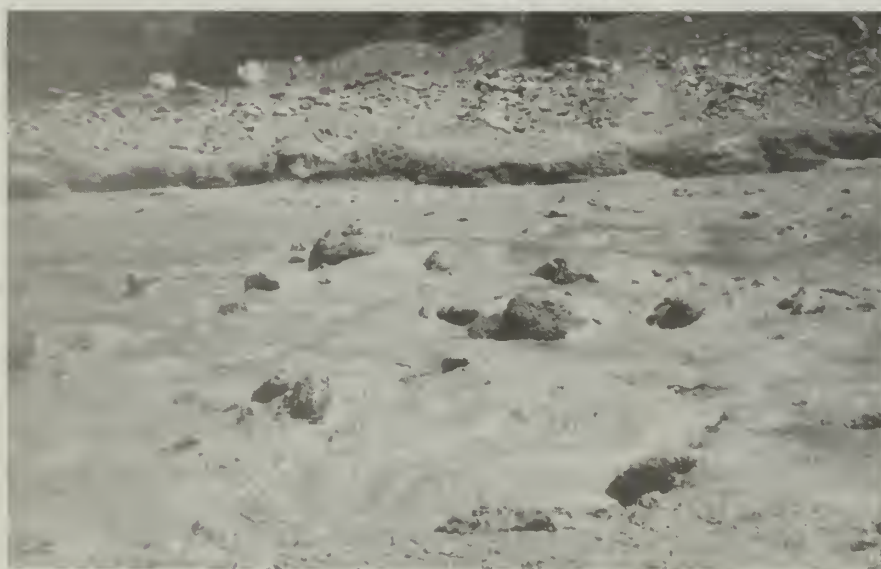
Figure 17. View of the mudflow in the area of deposition. Here the width is approximately 50 feet.

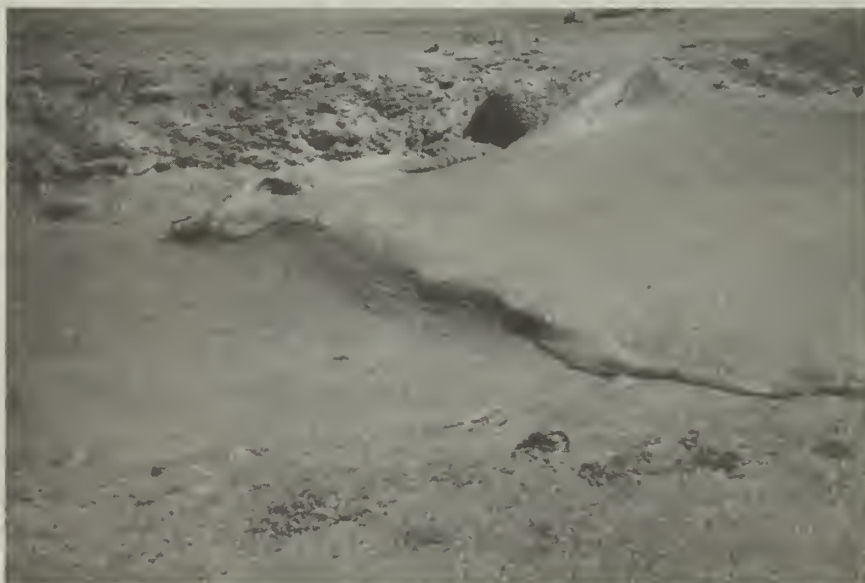
Figure 18. Translatory wave in gravelly sand, view at the lower sample site.

In the flood control channel of the alluvial fan, translatory waves 1 to several inches in amplitude were generated during the climactic stage (figure 18). These waves moved down channel at approximately twice the speed of advancing mudflows. Most waves
